TECHNICAL MEMORANDUM ARPAD-MR-77002

ULTRASONIC NONDESTRUCTIVE INSPECTION
OF XM650 ROCKET ASSISTED PROJECTILE
FOR BONDING QUALITY OF THE ROTATING BAND

JAY S. PASMAN

JULY 1977

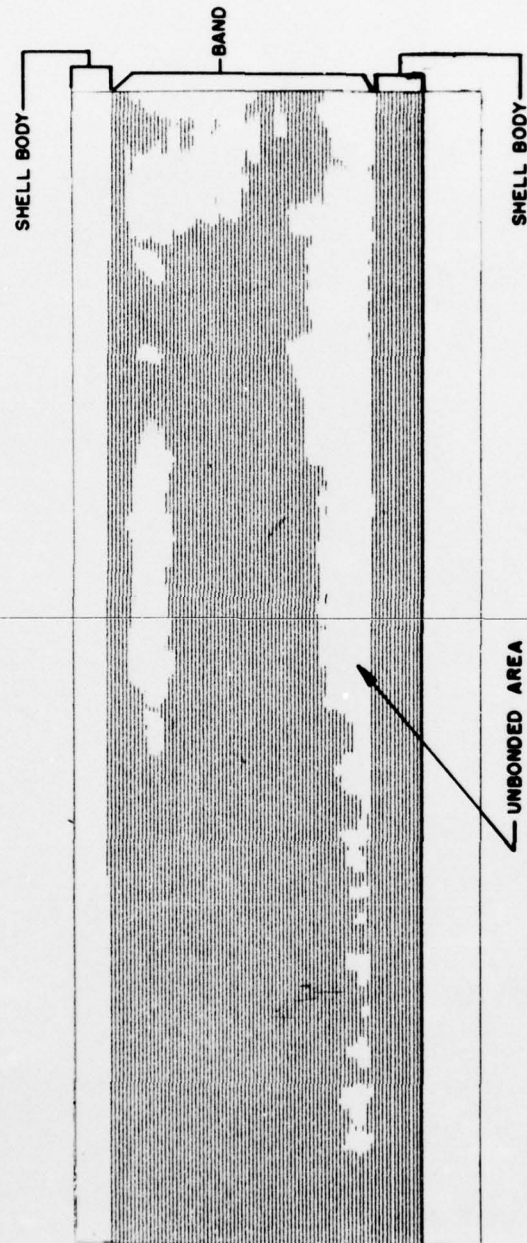
Fig 3 C-scan of a poorly bonded rotating band

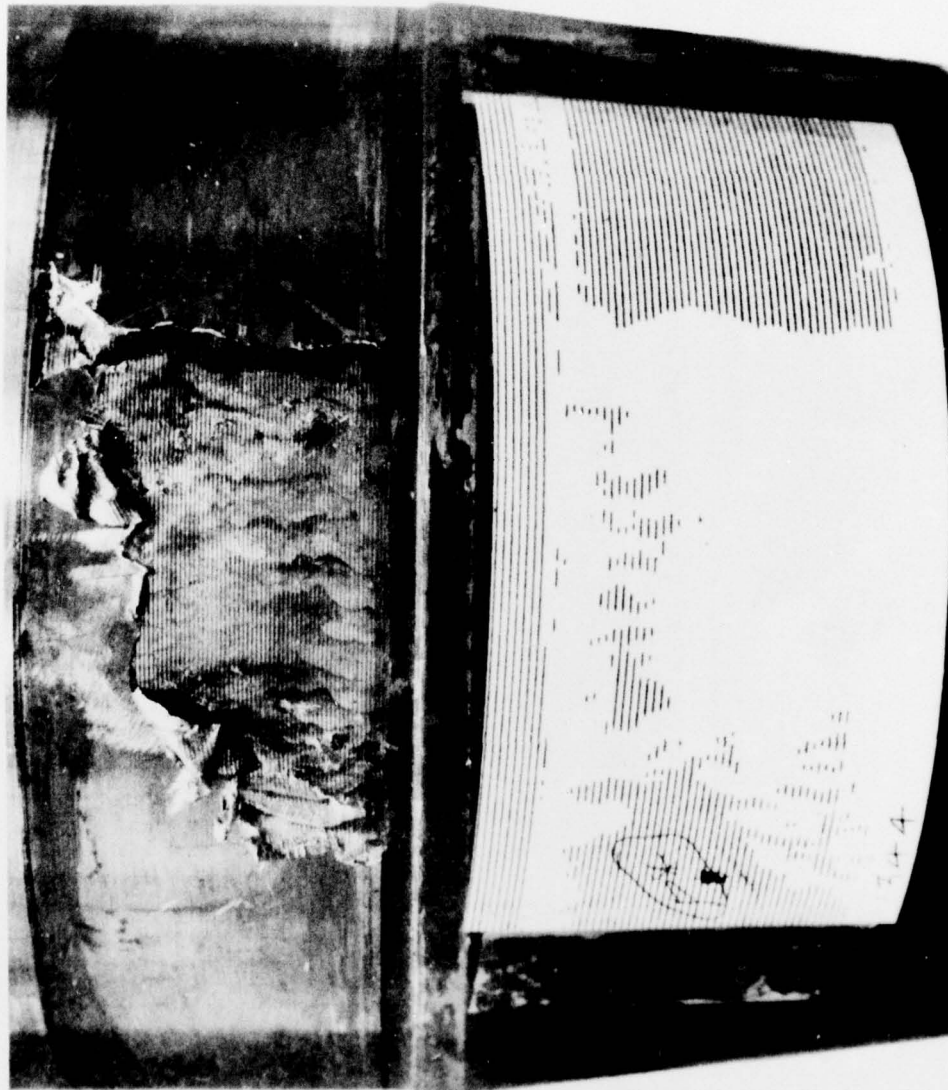
b. As the program progressed, the copper bands were removed from selected samples. The contours generally followed the pattern seen on the C-scan, although in many cases the flaw area appeared to be slightly smaller than on the C-scan chart. This is believed to be caused by a transitional zone where the bond is of marginal quality.

Fig 4 Unbonded area - comparison of C-scan and
machined rotating band
